Advanced characterization techniques for SiC and PyC coatings on high-temperature reactor fuel particles

Abstract

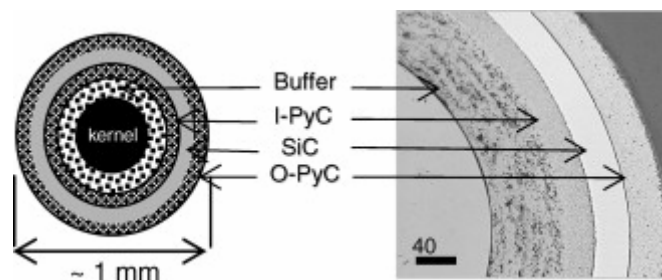
Fig. 1. Particle cross-section showing the kernel, the buffer, the inner PyC (I-PyC), the SiC and the outer PyC (O-PyC).

Fuel particles are produced by a fluidized bed Chemical Vapor Deposition (CVD) process according to the original technique conserved, enhanced and currently investigated by the CEA in Grenoble using simulated coated particles with $\text{ZrO}_2\text{--Y}_2\text{O}_3$ kernels and a three fluidized bed furnace. A typical coated particle cross-section is shown in Fig. 1. The kernel is coated by a low density pyrocarbon layer (buffer) and three successive dense layers: an inner dense pyrocarbon layer (I-PyC), a silicon carbide (SiC) layer and an outer dense pyrocarbon layer (O-PyC).

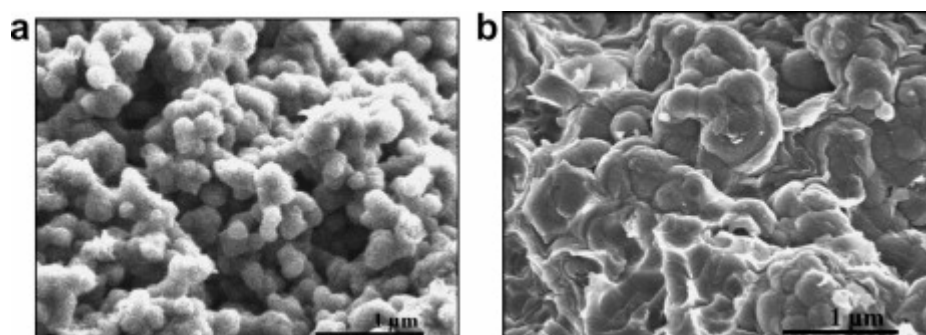
Fig. 2. Fracture surfaces observed by SEM of (a) the buffer and (b) the dense I-PyC.

The buffer and dense PyC texture observed by SEM on fracture surfaces is shown in Fig. 2. The buffer is constituted by concentric growth features (spheroids) 300–400 nm in diameter (Fig. 2(a)). A heterogeneous distribution of large cavities is evidenced. Dense PyC is composed of agglomerated spheroids (Fig. 2(b)) about 400 nm in diameter, typical of reactions in the gas phase (homogeneous growth) [5]. On the fracture surfaces, PyC deposited directly on the surface (heterogeneous growth), can also be distinguished between the agglomerates (Fig. 2(b)).

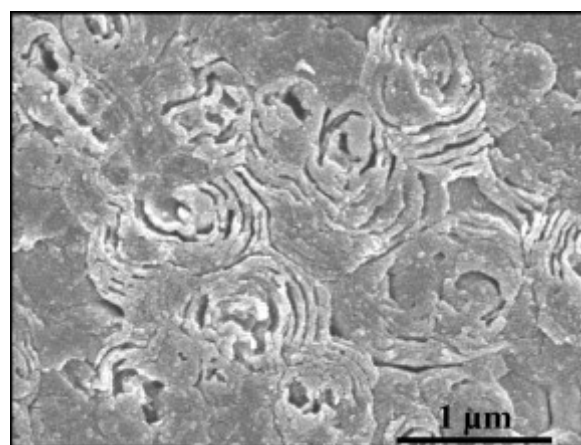
Fig. 3. Polished and etched cross-section of the dense I-PyC observed by SEM.

Murakami chemical etching evidences the main features of the PyC microstructures. The texture of carbon spheroids is clearly visible on a polished and etched cross-section of dense PyC (Fig. 3). They exhibit an onion-like texture with concentric carbon layers. Etching occurs preferentially in regions corresponding to direct PyC coating on the surface. In these regions, the deposit is not concentric (anisotropic fraction or 'layered' carbon).

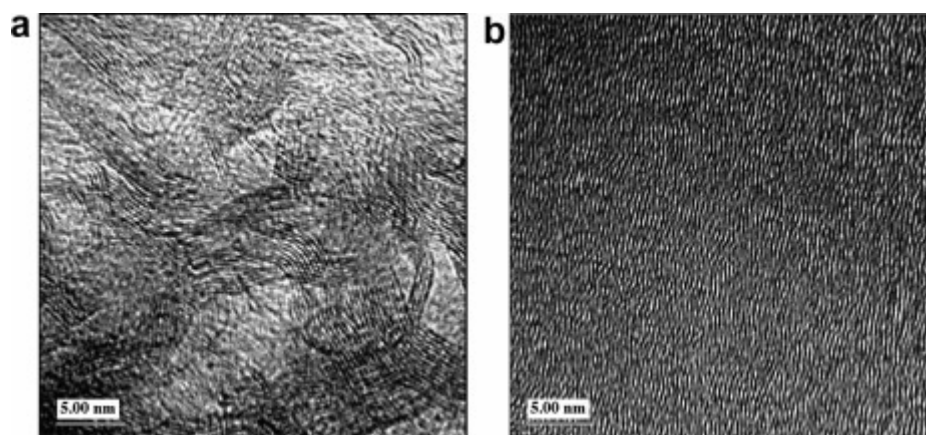
Fig. 4. HR-TEM micrographs of different pyrocarbons: (a) the buffer and (b) the I-PyC. Lattice fringe images correspond to the (0 0 2) carbon layers.

The structures of the buffer and dense PyC observed by High-Resolution TEM (HR-TEM) are totally different. The buffer is composed of randomly oriented piles of long carbon layers (Fig. 4(a)). This nanostructure is known to favor low density via significant inter-layer porosity. Carbon layers deposited in the case of I-PyC are shorter and arranged in compact piles (Fig. 4(b)). These observations are consistent with data from the literature. In the 1970s, Pollman et al. [1] reported on the state of the art of TEM analysis, and noted that three different structural arrangements (referred to as ‘tangled fiber’, ‘mosaic’ and ‘layered’) can occur in PyC. A comparison of this classification well described in [1] with observations made in the present study indicates a ‘tangled fiber’ structure in the buffer and a ‘mosaic’ structure in the dense PyC.

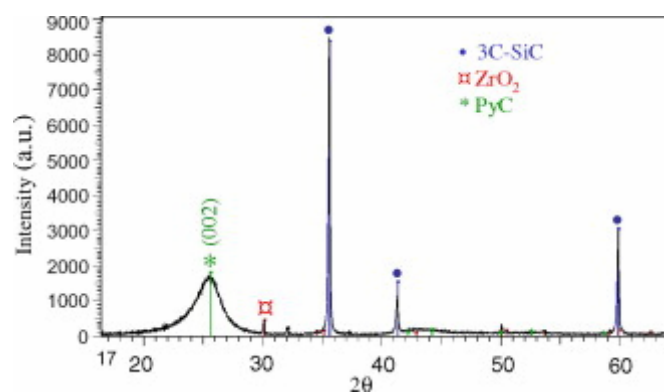
Fig. 5. The XRD pattern of HTR particles.

The apparent crystallite size (L_c) and d_{002} -spacing were obtained using X-ray diffraction. The Scherrer relation and Bragg’s law were used respectively to determine L_c and d_{002} -spacing. The particles were measured directly (all particles are in the same plane). For Cu K α radiation, the attenuation of the incident beam is about 98% at the outer surface of the I-PyC layer (SiC is a stronger X-ray attenuator). This indicates a preponderant contribution of O-PyC to the (0 0 2) diffraction peak (Fig. 5). Therefore, calculations can only be made for the O-PyC layer. L_c is about 30 Å; this result is very similar to that reported in the 1970s for ‘mosaic’ structure [1]. d_{002} is about 3.47 Å and is typical of turbostratic pyrocarbons.

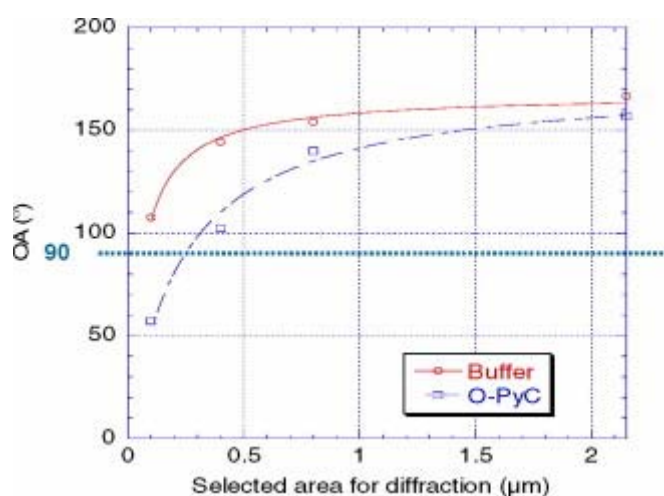
Fig. 6. Typical plot of the electron diffraction data for the buffer and for the dense PyC: OA versus the selected area for the diffraction.

An example of the results obtained from such measurements is presented in Fig. 6. Data corresponding to a buffer and an O-PyC layer can be distinguished on the plot. These curves show that PyC isotropy is a scale function of the material. The isotropy thresholds are not the same for the buffer and the dense PyC. The buffer has a structural isotropy (at the scale of a

few tens of nanometers) whereas for the dense PyC a textural isotropy occurs at long range (at the scale of a few hundreds of nanometers or statistical isotropy).

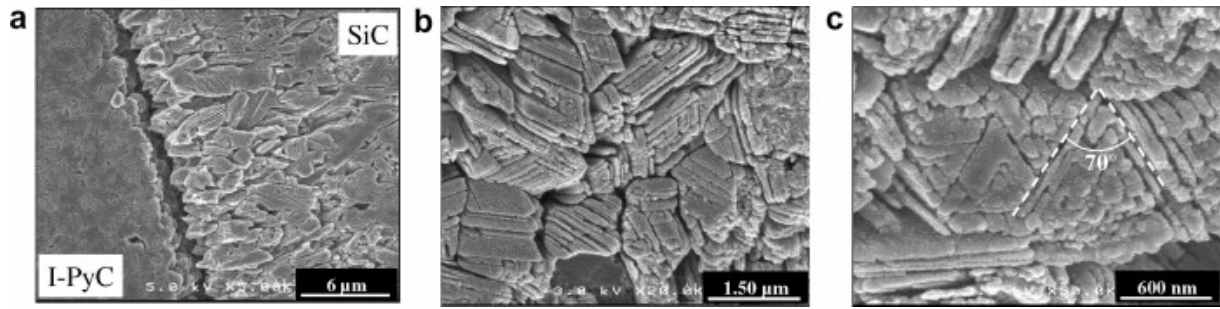
Fig. 7. SEM micrographs of SiC etched for 60 min (a) polished section perpendicular to the plane of deposition showing columnar grains; (b) and (c) sections parallel to the plane of deposition showing planar faults.

Etching reveals the presence of fine columnar grains in the equatorial polished section (Fig. 7(a)). The width and length are about 1 μm and about 4–5 μm , respectively. It seems that the etching is stronger in the first microns of near the I-PyC/SiC interface (Fig. 7(a)). This phenomenon may be due to the existence of very small grains. This heterogeneous microstructure is confirmed by EBSD measurements. EBSD maps illustrate the grain size distribution and show that finer grains are present at the beginning of the SiC coating and coarser at the end [10]. The interface between I-PyC and SiC is expected to be strong, because the small SiC grains can penetrate into the I-PyC porosities (the outer surface of the I-PyC is rough and porous). A tightly bonded I-PyC/SiC interface is important because bond separation can result in stress concentration in the SiC layer that may lead to the failure.

Moreover the etched grains exhibit many apparent planar faults, which cross the entire grain or stop inside (Fig. 7(b)). They are relatively homogeneously dispersed over the grains and often tend to exhibit a particular orientation relationship at about 70° to each other (Fig. 7(c)). Similar features were evidenced by Gulden, from General Atomic, in the 1970s [9].

Fig. 9(b) shows an example of such stacking faults on a $\{1\ 1\ 1\}$ β -SiC surface. It is interesting to note that the dihedral $\{1\ 1\ 1\}$ angle between two set of stacking faults that intersect is 70.5°, i.e. similar to what is observed on the etched SiC (Fig. 7). This is the interplanar angle of crystallographically equivalent (1 1 1) planes.

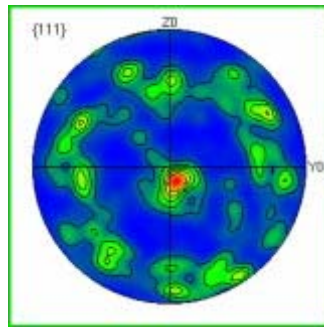
Fig. 8. $\{1\ 1\ 1\}$ pole figure showing the texture of SiC coatings.

Grains exhibit a preferred orientation during growth. The pole figures obtained by EBSD analysis (Fig. 8) show that there is a low 1 1 1 fiber texture (1 1 1 pole parallel to the growth direction). This preferred orientation is commonly observed in CVD SiC deposits [10]. A more comprehensive paper has been published in particular on EBSD analysis of the SiC coatings [11].

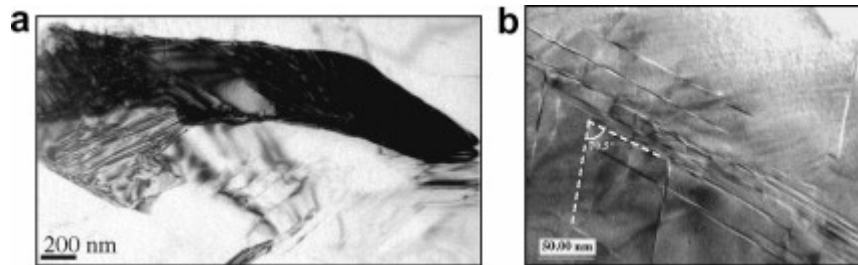
Fig. 9. (a) Bright field TEM image showing a columnar β -SiC grain divided into sub-grains, (b) HR-TEM image showing stacking faults lying on $\{1\ 1\ 1\}$ planes.

TEM examination at higher magnification confirms the previously described grain dimensions and morphology, and demonstrates the occurrence of sub-grains in some of them (the coarser ones). Two sub-grains can be observed in Fig. 9(a): one with dark contrast and another isomorph with a grey one. According to the SAED diagrams, the crystallographic nature of the coating is β -SiC. SiC exists in a wide variety of crystallographic forms known as polytypes, which differ from one another only in the (1 1 1) stacking of the SiC diatomic layers (Si–C). β -SiC or 3C is the cubic form of SiC. When the deposit is observed along the $[112, \bar{0}]$ direction, stacking faults oriented parallel with the (1 1 1) planes, can be identified.

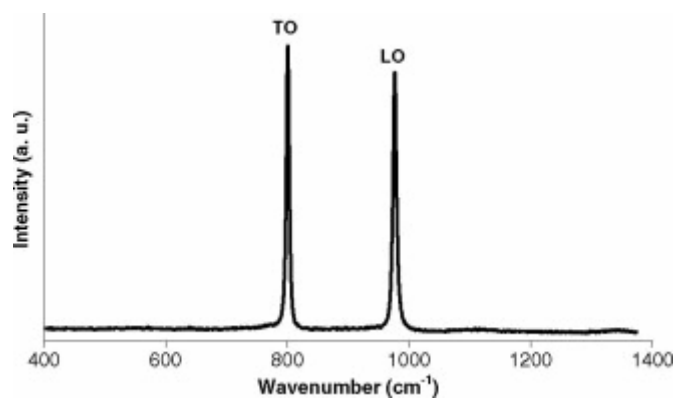
Fig. 10. First-order Raman spectrum obtained on SiC cross-section.

As already noted, all the deposits characterized by Raman microspectrometry consist exclusively of β -SiC. Raman spectra also demonstrate that there is no excess carbon and

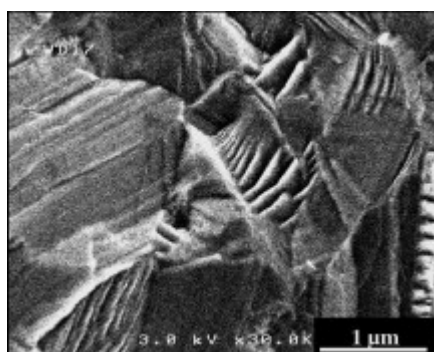
Fig. 11. Fracture surface of SiC observed by SEM.

The quality of grain boundaries is of considerable interest because they play an important role during the migration of fission products. Preliminary observations directly on fracture surfaces reveal that cleavage is mainly transgranular (hackle marks in Fig. 11). This is in line with high-purity and porosity-free grain boundaries. This feature is confirmed by TEM examination and energy dispersive X-ray (EDX) spectrometry coupled with TEM. No intergranular porosity is apparent and EDX results suggest that no segregation exists. It may thus be concluded that such grain boundaries are of high quality.

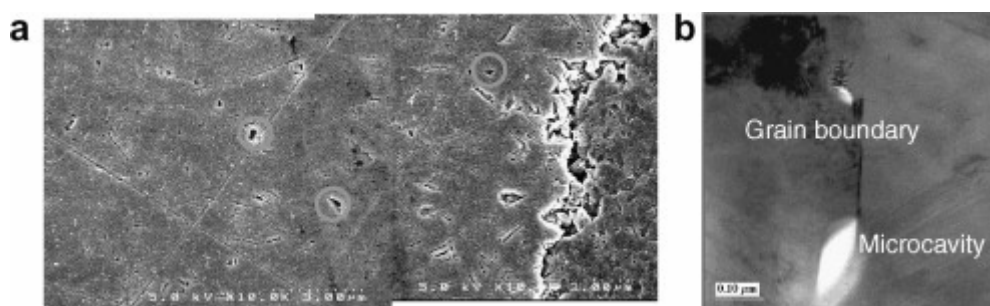
Fig. 12. (a) SEM micrograph of SiC etched for 10 min. Polished section perpendicular to the plane of deposition. (b) TEM micrograph of SiC.

SEM observations of fracture surfaces and external cap show no apparent pores. It would thus appear that there is no crack initiator in the SiC deposit. This feature was checked by using a short etching procedure which revealed some potential cracks: microcavities are present in the area close to the SiC/I-PyC interface (rings in Fig. 12(a)). These microcavities are also detected by TEM examinations (Fig. 12(b)). When the internal gas pressure increases, a tensile hook stress can develop in the SiC layer, flaws can then propagate and generate radial cracks in the SiC deposit.

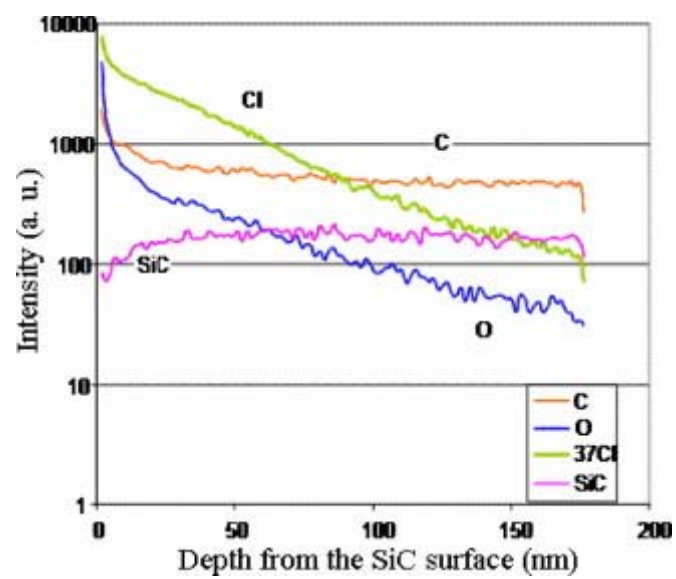
Fig. 13. Depth profile of ³⁷Cl, Si, O, C in the SiC surface.

Chlorine, which may be a residue of the CH_3SiCl_3 gas precursor, was analyzed by electron probe microanalysis (EPMA) on cross sections. Under irradiation, the stable isotope ^{37}Cl becomes radioactive (as ^{36}Cl), so it is of great importance that the deposit contains no chlorine to prevent the release of radioactivity into the environment. The results indicate that it is present in only very small amounts, its concentration is always less than 15 ppm. Additional data are obtained by depth profiles recorded by static secondary ion mass spectrometry (SSIMS). Chlorine is more abundant at the extreme surface but its depth-concentration decreases very rapidly (Fig. 13).
